INITIAL STUDY OF A  
COAL GASIFICATION WASTE SITE  
BROCKVILLE, ONTARIO

Report prepared for:  
Waste Management Branch  
Ontario Ministry of the Environment

Report prepared by:  
Trow, Dames & Moore

MARCH 1991

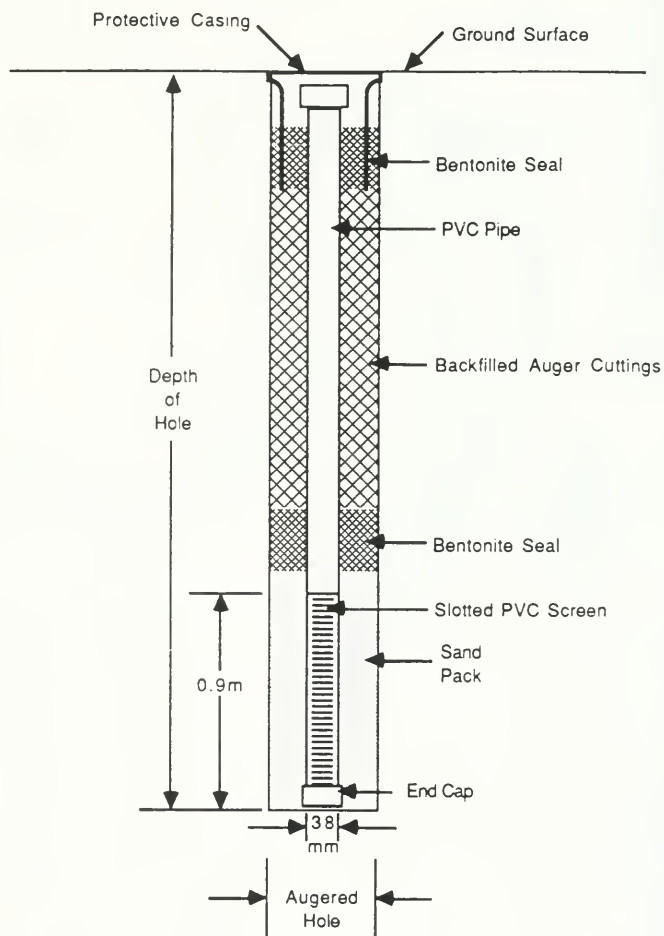
**FIGURE 8**

**ONTARIO MINISTRY  
OF THE ENVIRONMENT**  
Brockville Coal Gasification Plant  
TYPICAL OBSERVATION  
WELL INSTALLATION

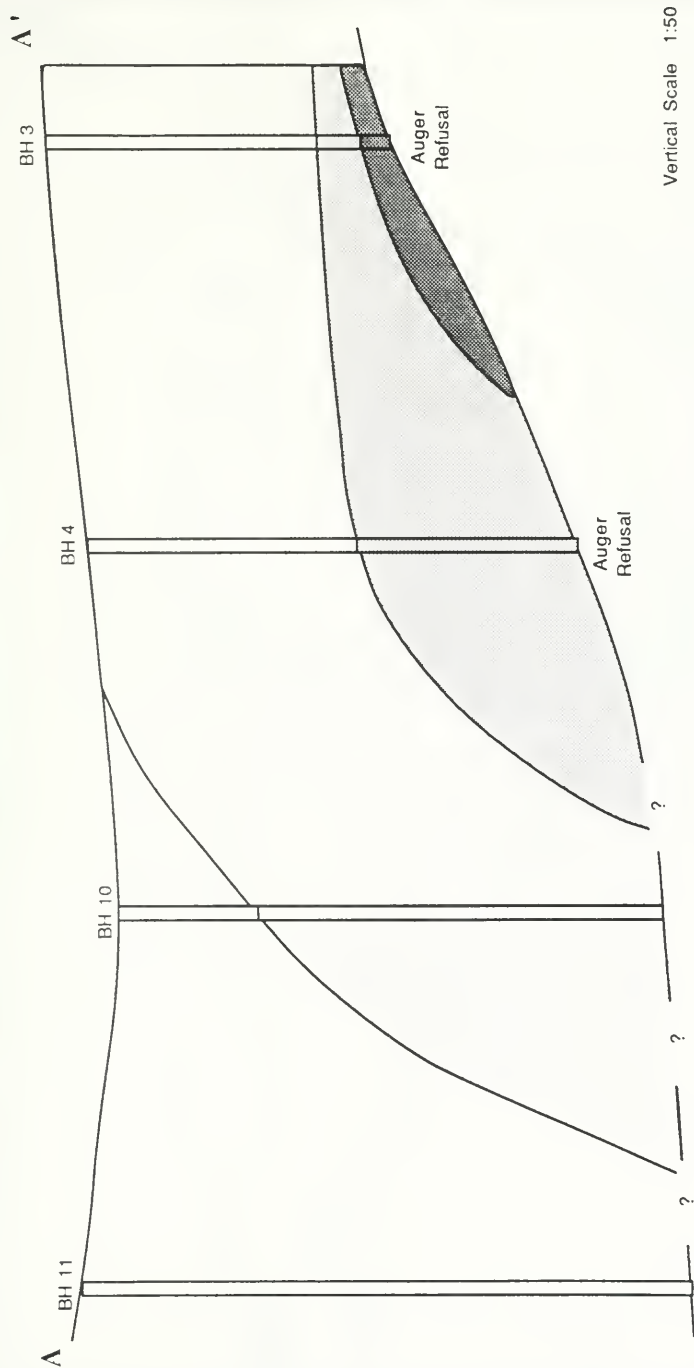
Proj. No.	10044-003
Scale:	N.T.S.
Date:	06-28-88
FIGURE 11

Visible coal tar contamination was observed at boreholes BH1, BH2, BH3, BH4, BH5, BH7 and BH8. It generally occurred within fractures in either the fill or the native material. Generally, the visible coal tar contamination was restricted to samples from depths of greater than 2.0 meters below the ground surface. In addition, boreholes BH1, BH2, BH3, and BH7, contained a thin liquid coal tar saturated zone immediately above the level at which refusal was encountered. This may indicate that dense non-aqueous phase liquid (DNAPL) components of the tar have been migrating downward and have been accumulating at the bedrock surface or the surface of other impermeable objects. The depths to refusal in those boreholes at which an accumulation of coal tar was observed, range from 3.0 to 4.8 meters below ground surface. Figures 10 and 11 show the estimated areal and vertical extent of coal tar contamination observed.

ONTARIO MINISTRY  
OF THE ENVIRONMENT  
Brockville Coal Gasification Plant  
SCHEMATIC CROSS SECTION  
OF CONTAMINANT CLASSES
